LOUISIANA DEPARTMENT OF WILDLIFE & FISHERIES

MILL CREEK RESERVOIR

**AQUATIC VEGETATION TYPE MAPS
AND NARRATIVES 2018**

APPENDIX III – Aquatic Vegetation Type Maps

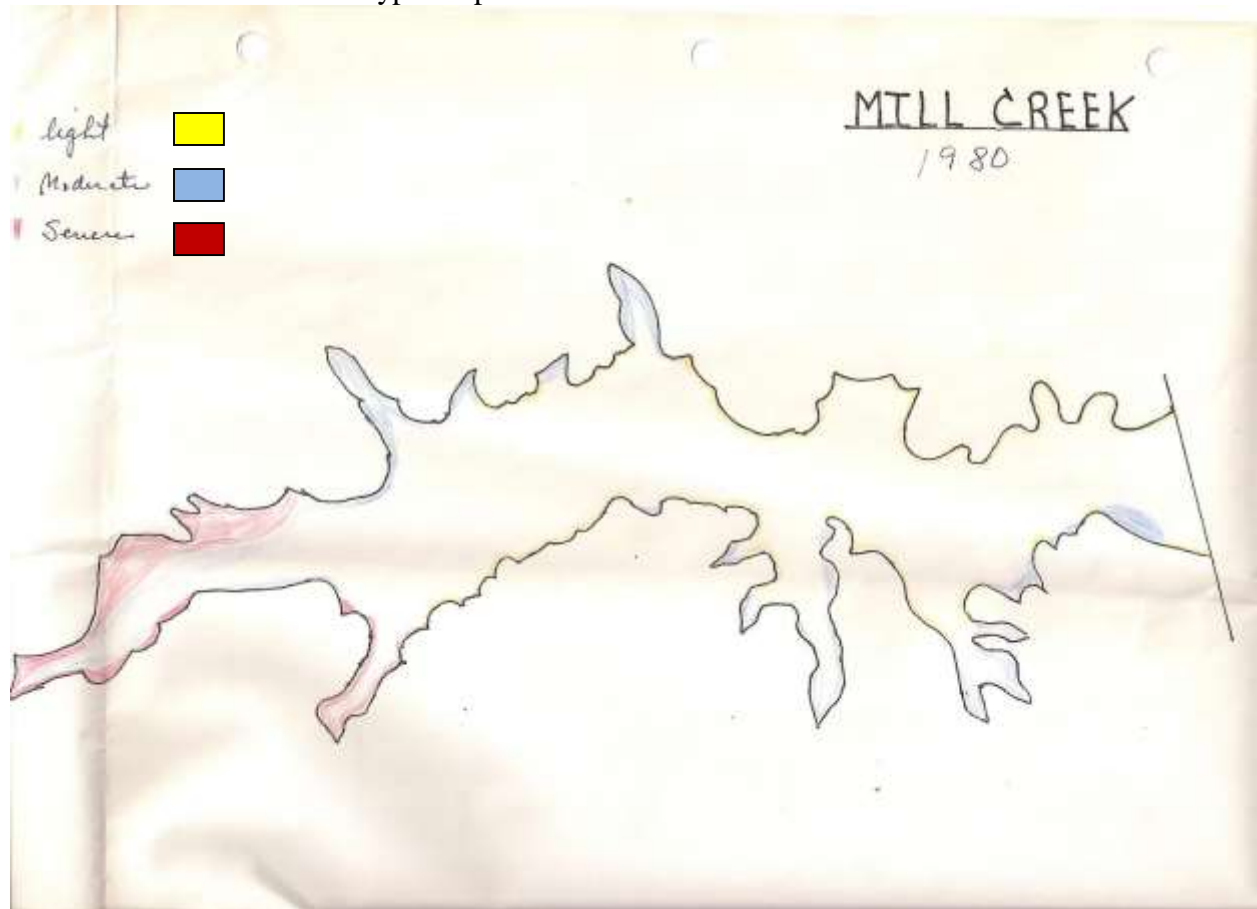
1980 Mill Creek Reservoir Type Map

The water was clear and no plankton bloom was noticed. More of the dead timber has fallen and stumps are everywhere. Navigation out of the cut channels and boat roads is very difficult.

The submersed aquatic plants listed in order of importance are fanwort (*Cabomba caroliniana*), bladderwort (*Utricularia* sp.), and southern watergrass (*Luziola fluitans*). The infestation of fanwort was increased to the point of being severe in about one-fifth of the lake, this being in the upper end. There is also a larger infestation of fanwort close to the dam. Infestations of bladderwort are about the same.

The marginal plants are about the same as they were last year with water shield (*Brasenia schreberi*) being the major plant. Infestations are no larger than last year.

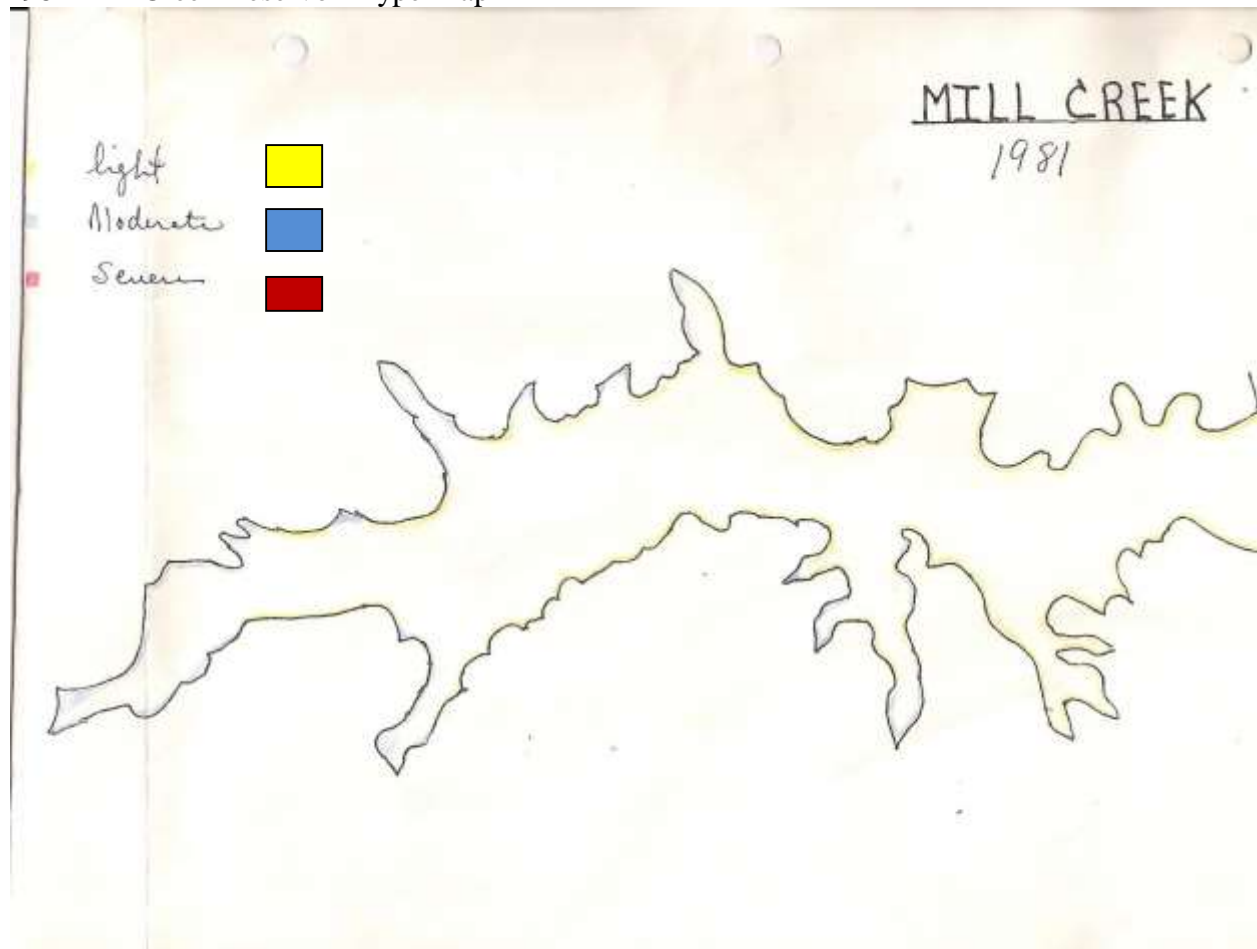
1981 Mill Creek Reservoir Type Map

The aquatic plants noted were fanwort (*Cabomba caroliniana*), bladderwort (*Utricularia* sp.), spikerush (*Eleocharis* sp.) and water shield (*Brasenia schreberi*).

The upper end of the lake had a light infestation of fanwort and bladderwort. The remainder of the lake had light to minor infestations of bladderwort and spikerush.

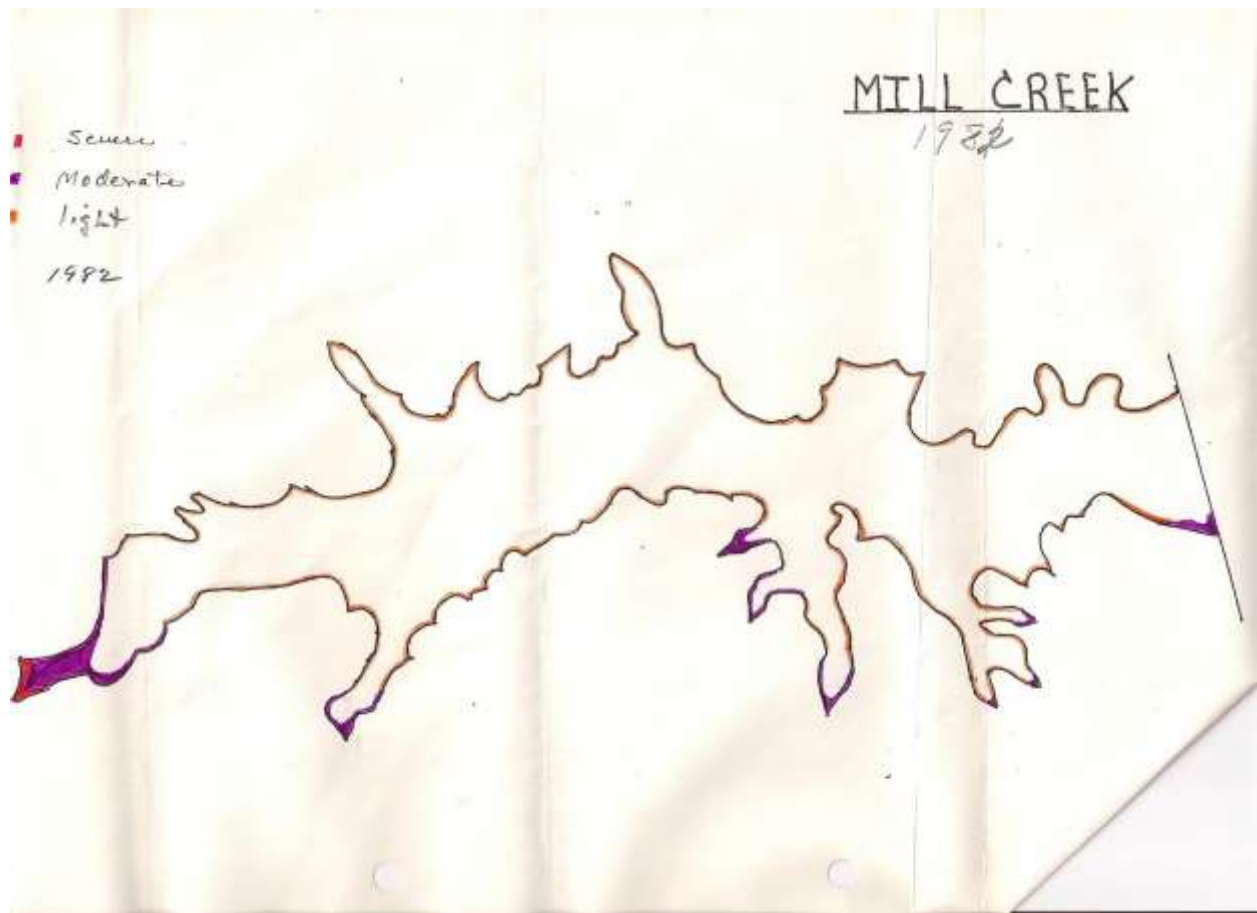
1982 Mill Creek Reservoir Type Map

The submersed plants noted were fanwort (*Cabomba caroliniana*), bladderwort (*Utricularia* sp.), coontail (*Ceratophyllum demersum*), and filamentous algae. There was a small severe infestation of submersed vegetation in the upper end of the lake. There was just a small amount of *Ceratophyllum* noted.

The moderate infestations were primarily bladderwort and filamentous algae. Two areas of moderate infestations contained fanwort, one in the mid-portion of the lake and the other at the dam.

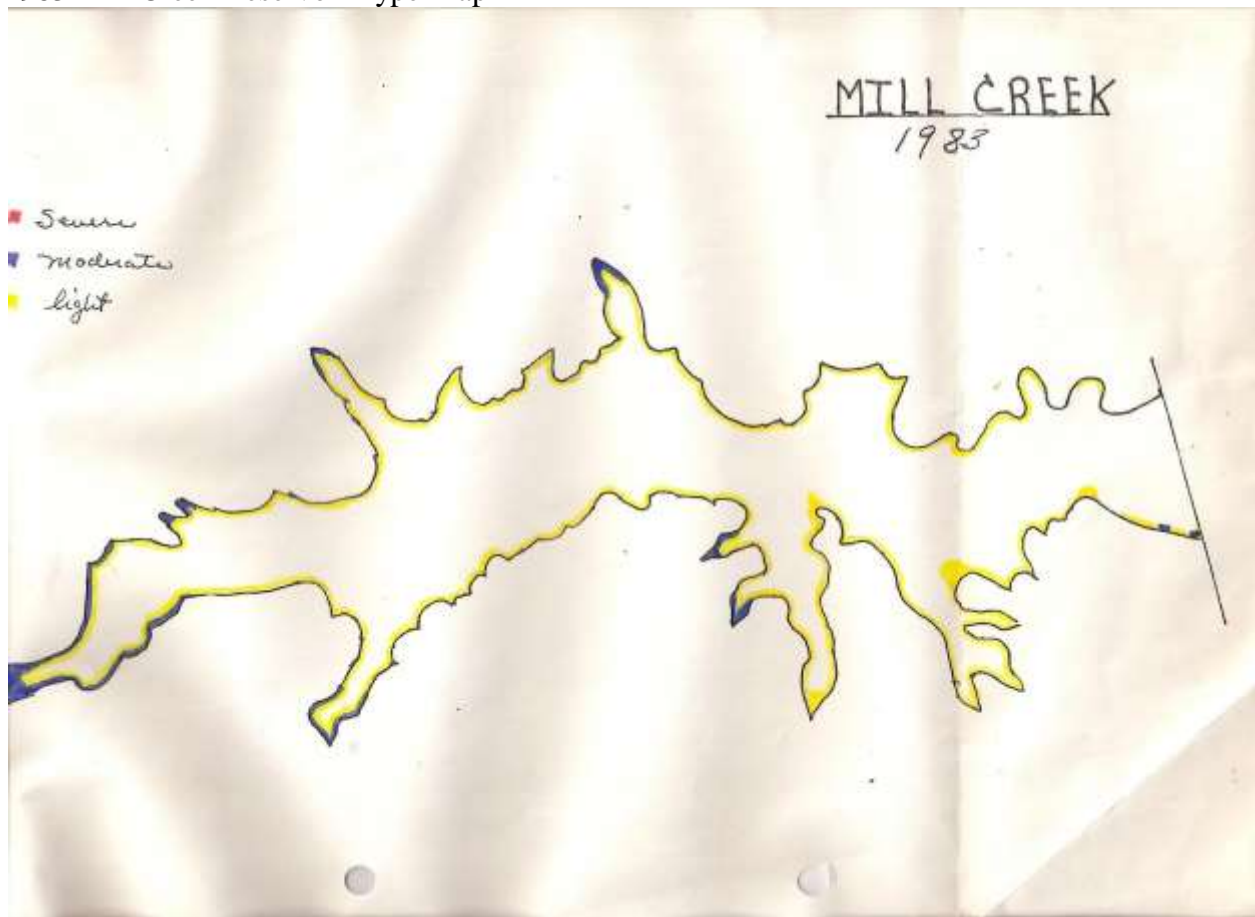
1983 Mill Creek Reservoir Type Map

There were no severe infestations of aquatic plants in Mill Creek Reservoir.

Most of the moderate infestations were primarily comprised of bladderwort (*Utricularia* sp.) and pondweed (*Potamogeton* sp.) mixed with filamentous algae. The moderate infestation in the area of the dam and the south side of the lake consisted mainly of fanwort (*Cabomba caroliniana*), and filamentous algae.

The light infestations were comprised of pondweed, bladderwort, fanwort, and spikerush (*Eleocharis* sp.).

In summary Mill Creek in in good condition. There has been no significant increase in submersed plants since last year. There has been a decrease in fanwort in the upper end. The drawdown in 1980 almost eliminated watershield, but there are some plants in the lake. Marginal plants are in tolerable numbers.

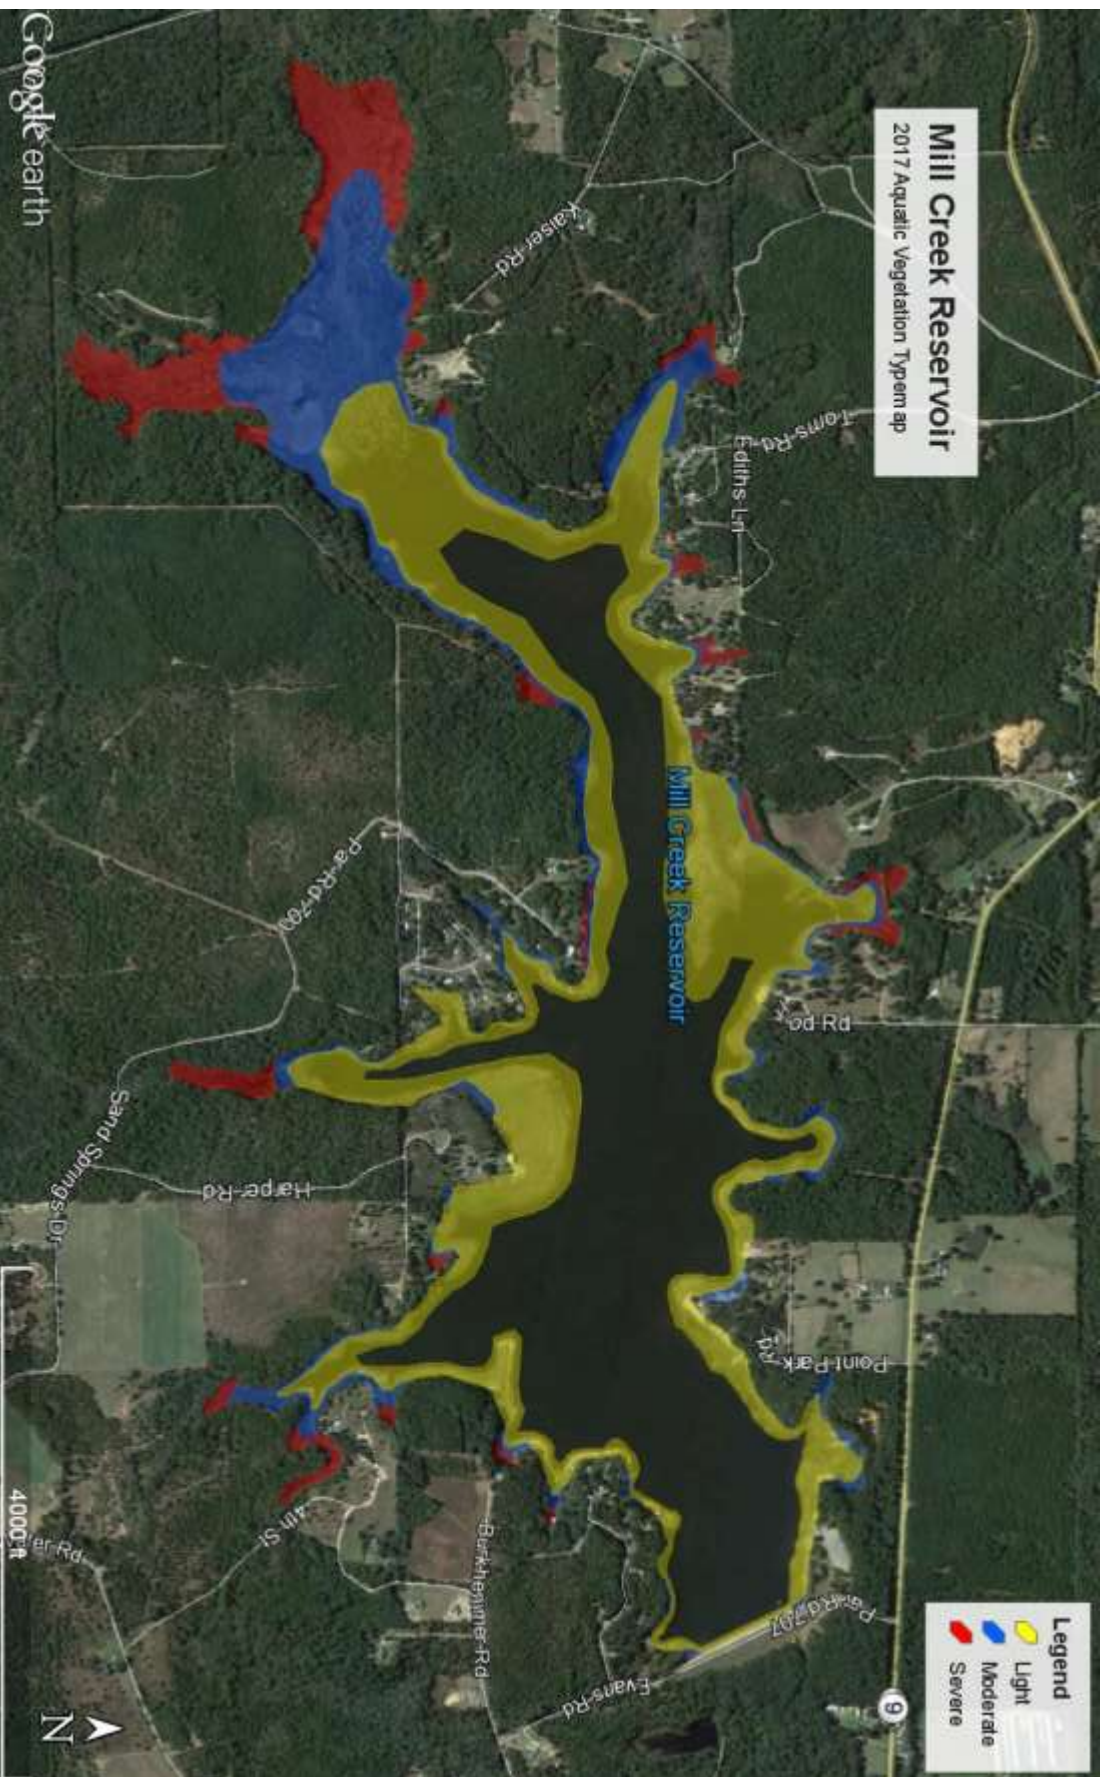
Mill Creek Reservoir Bienville Parish, LA Vegetation Type Map 2017

The majority of Mill Creek Reservoir is not adversely affected by aquatic vegetation. Less than 15% of the lake has vegetation coverage that could be described as moderate or severe. Only the extreme upper end of the lake and the backs of some coves have significant vegetation coverage. Submerged vegetation can be found in 25-30% of the reservoir to some extent, but is not impacting access.

Watershield was the predominant emergent plant found in Mill Creek Reservoir. It was found in the upper end of the lake, the backs of several coves and a couple of shallow flats along the shoreline. In most areas where watershield occurred the coverage was dense. Creeping water primrose, alligator-weed, fragrant water lily, pondweed, southern watergrass, and American lotus were found in a few locations on the lake. Most of the emergent vegetation in water less than 3 ft. deep, but occasionally emergent vegetation was found growing in 5 to 6 ft. of water.

Submersed vegetation was present out to depths of approximately 10 feet. In the deeper areas the submersed vegetation appeared to be sparse based on what was collected with a drag. The majority of the submersed vegetation was found in depths of 7 feet or less. In most areas the vegetation was not topped out, but was growing several feet off the lake bottom. Topped out submerged vegetation was only found in water 3 feet or less in depth. The primary species were bladderwort, variable-leaf milfoil, fanwort and widgeon grass.

If consolidated, approximately 5 acres of giant salvinia were found on the entire lake. Salvinia plants were randomly found at very low densities mixed in with other vegetation such as watershield. A few small mats have persisted in the upper reaches and extreme shallow areas at the head of the lake.

Giant salvinia was discovered on Mill Creek Reservoir in 2013. Foliar herbicide applications have been ongoing as needed since the plant was discovered. Giant salvinia has not covered large areas of the lake thus far, but persists at low levels primarily on the upper end of Mill Creek.

Mill Creek Reservoir underwent a fall / winter drawdown beginning after Labor Day in 2014 and continuing through the end of January 2015. Vegetation coverage was greatly reduced following this drawdown. Surveys conducted during 2015 and 2016 indicate a gradual expansion of the aquatic vegetation in Mill Creek Reservoir. This trend is continuing from what was observed during the 2017 typemap survey. Current vegetation coverage is near ideal for fisheries production. Access for shoreline property owners is impeded in a few areas of the lake by dense growth of watershield.
